CURRENT SPECTRUM ANALYSIS

IDENTIFIABLE FAILURE MODES

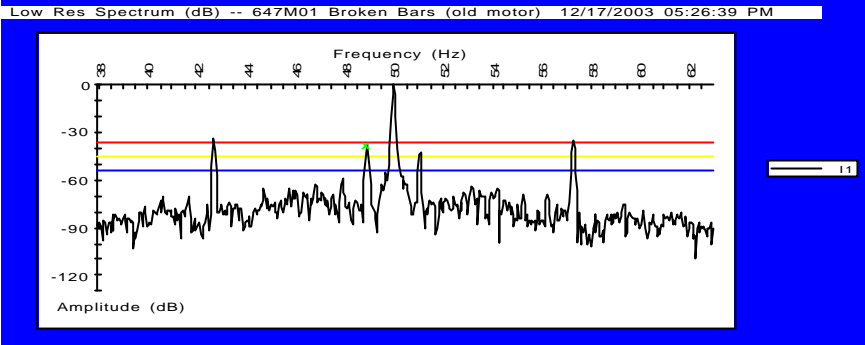
A higher than expected F_p amplitude for the load on the motor prompted a check of the 5th harmonic spectrum.

This motor was running hotter than other identical motors on site and had occasionally tripped on starting. The motor was removed from service during a maintenance day and numerous broken rotor bars were identified with a visual inspection.

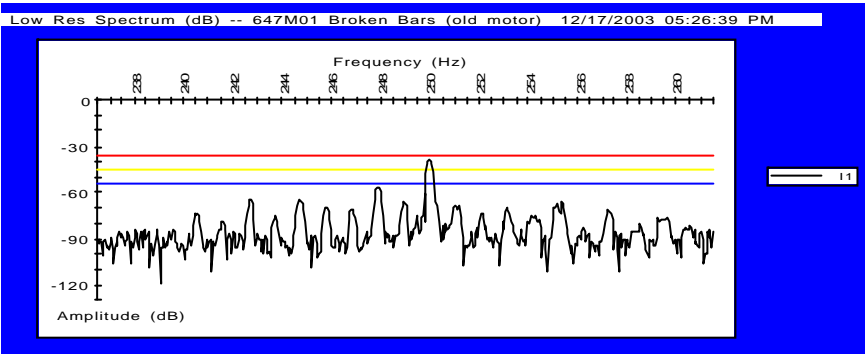
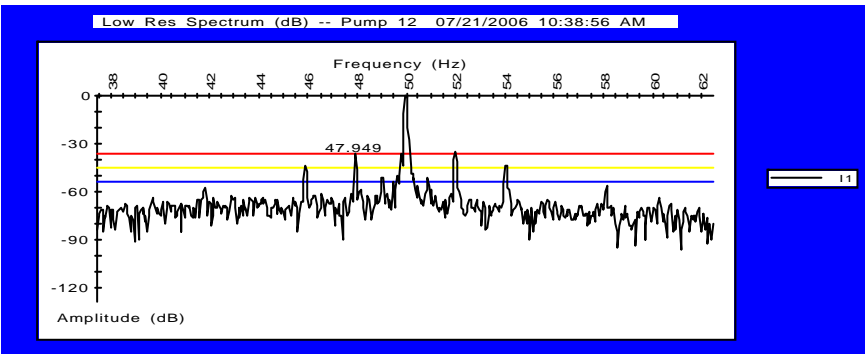
Current spectrum performed on motor due to nuisance trips on start and after a request by VA technicians for further investigation to electrical frequencies identified during routine vibration analysis.

This motor was removed from service and disassembled with 4 broken rotor bars being identified. 2 of the broken rotor bars had started to damage the rotor laminations due to centrifugal forces during running.

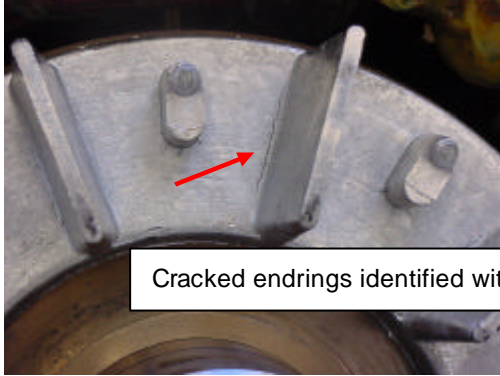
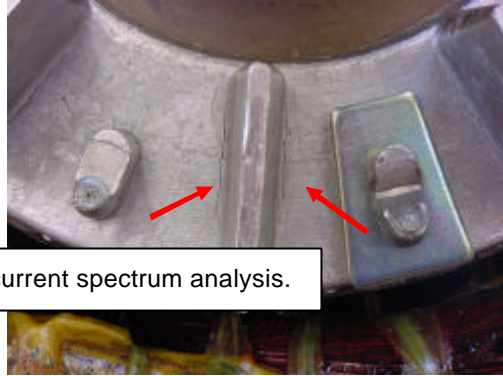
Cracked endrings identified with current spectrum analysis.

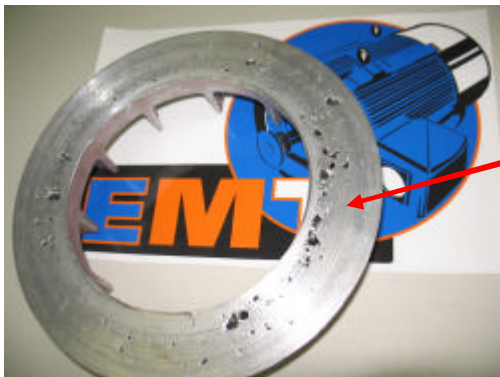
Porosity in die cast aluminum rotor identified using current spectrum analysis. This motor was new and would not start under loaded conditions.

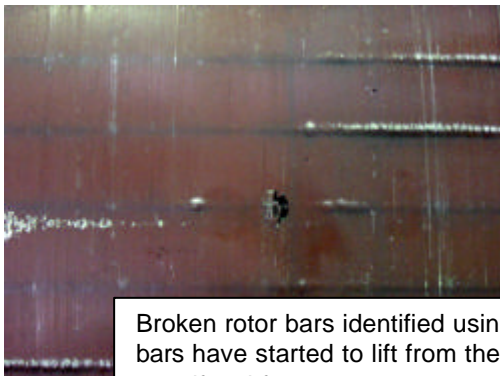
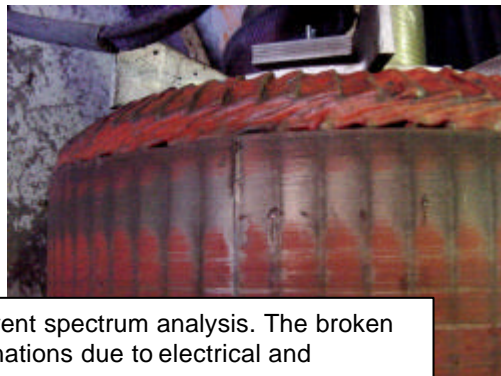
Broken rotor bars identified using current spectrum analysis. The broken bars have started to lift from the laminations due to electrical and centrifugal forces.
