CURRENT SPECTRUM ANALYSIS

IDENTIFIABLE FAILURE MODES

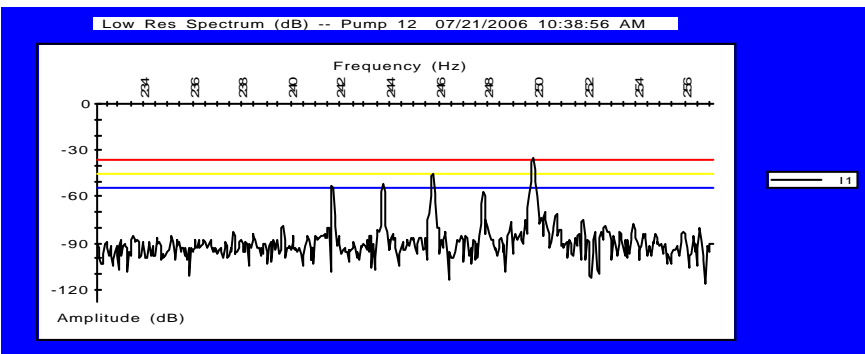
Current spectrum performed on motor due to nuisance trips on start and after a request by VA technicians for further investigation to electrical frequencies identified during routine vibration analysis.

This motor was removed from service and disassembled with 4 broken rotor bars being identified. 2 of the broken rotor bars had started to damage the rotor laminations due to centrifugal forces during running.
