## **ECCENTRICITY ANALYSIS**

### **IDENTIFIABLE FAILURE MODES**

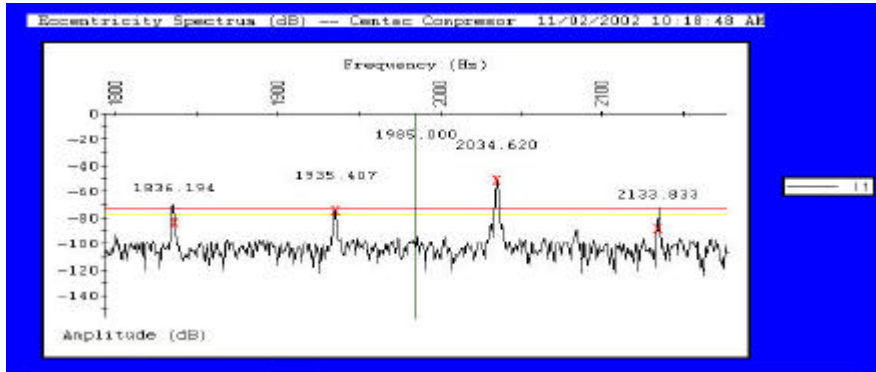
Electrical induced vibration in Centac compressor identified as eccentricity in motor due to mounting problem.

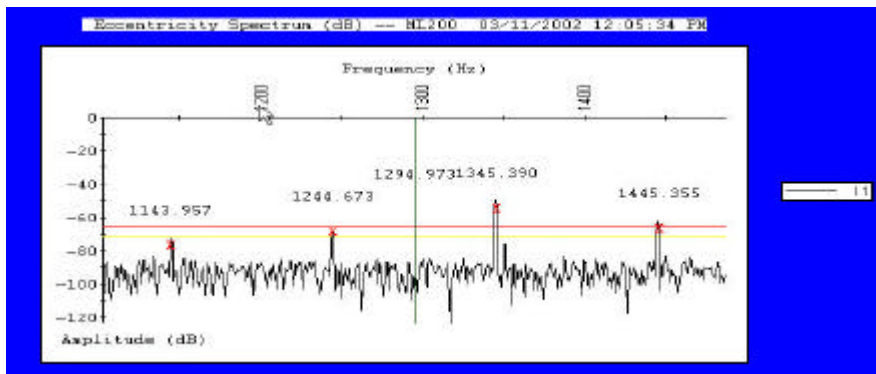
Eccentricity identified in belt driven equipment due to improper alignment and maintenance procedures.

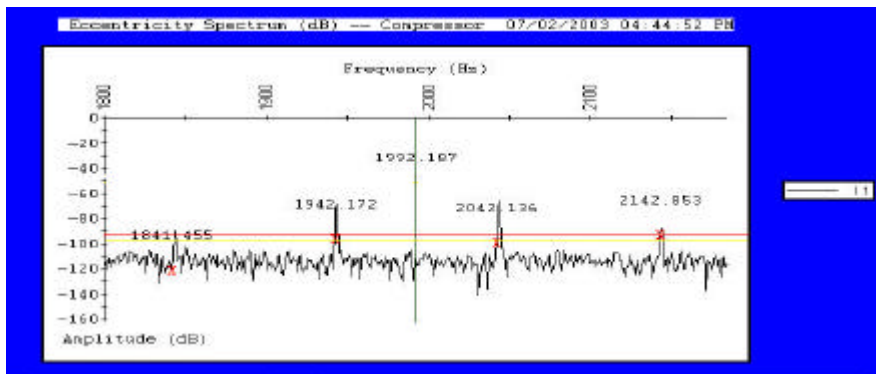
Eccentricity identified in HV motor. This motor failed in service 2 months after these readings were taken. Root cause analysis of the failure indicated vibration of the endwindings had caused the coil insulation to fail.

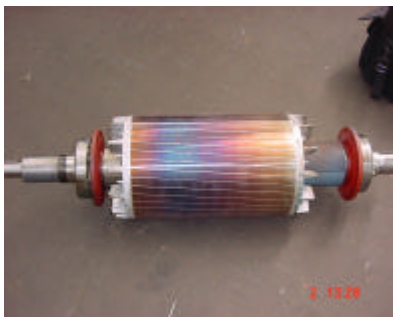
Excessive heat generated in rotor due to severe eccentricity. This motor was constantly tripping on vibration sensors fitted to the compressor. The vibration would cease with the cutting of power to the motor. The heat was transferring to the stator windings causing advanced thermal aging to the stator windings. Dimensional checks identified the stator core was misaligned in the frame by 3.4 mm.
